Report No. CG-D-39-78

HUMAN AND PHYSICAL FACTORS AFFECTING COLLISIONS,
RAMMINGS, AND GROUNDINGS ON WESTERN RIVERS AND
GULF INTRACOASTAL WATERWAYS

FINAL REPORT

U.S. DEPARTMENT OF TRANSPORTATION
United States Coast Guard
Office of Research and Development
Washington, D.C. 20590

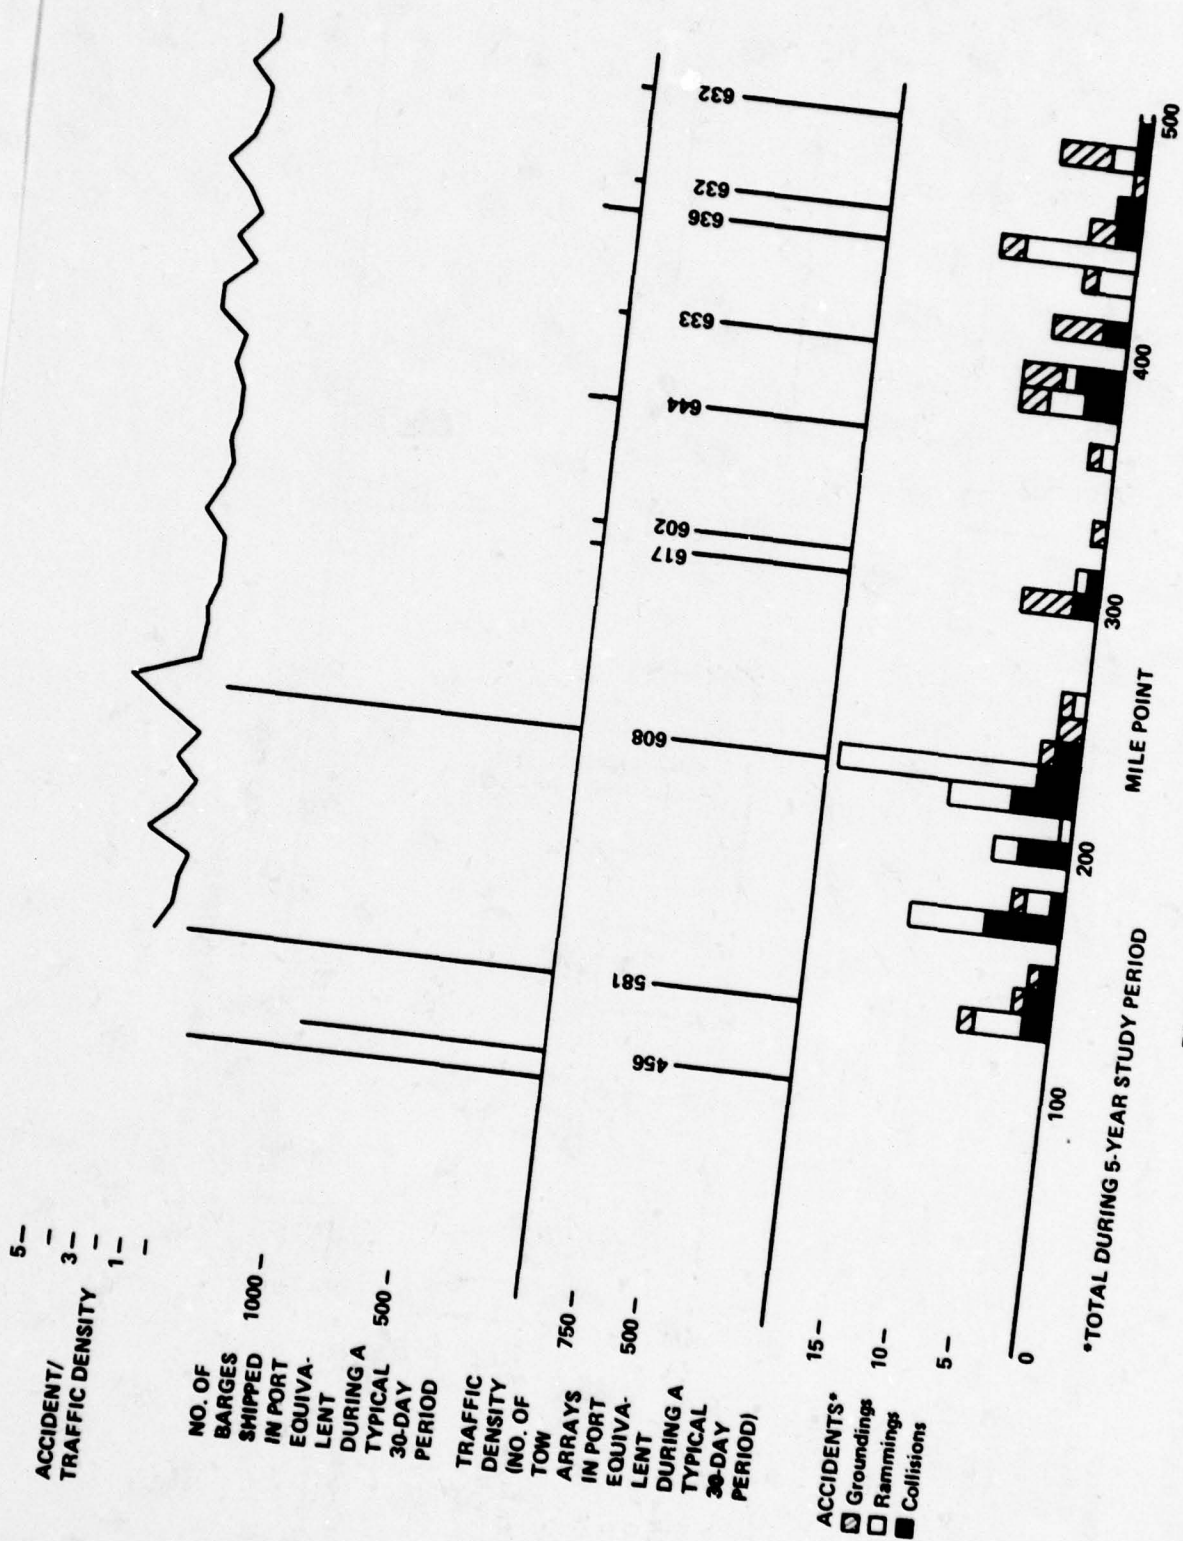
FIGURE A.2. TRAFFIC VERSUS ACCIDENTS
LOWER MISSISSIPPI RIVER
